COMBI FAULT HANDLING

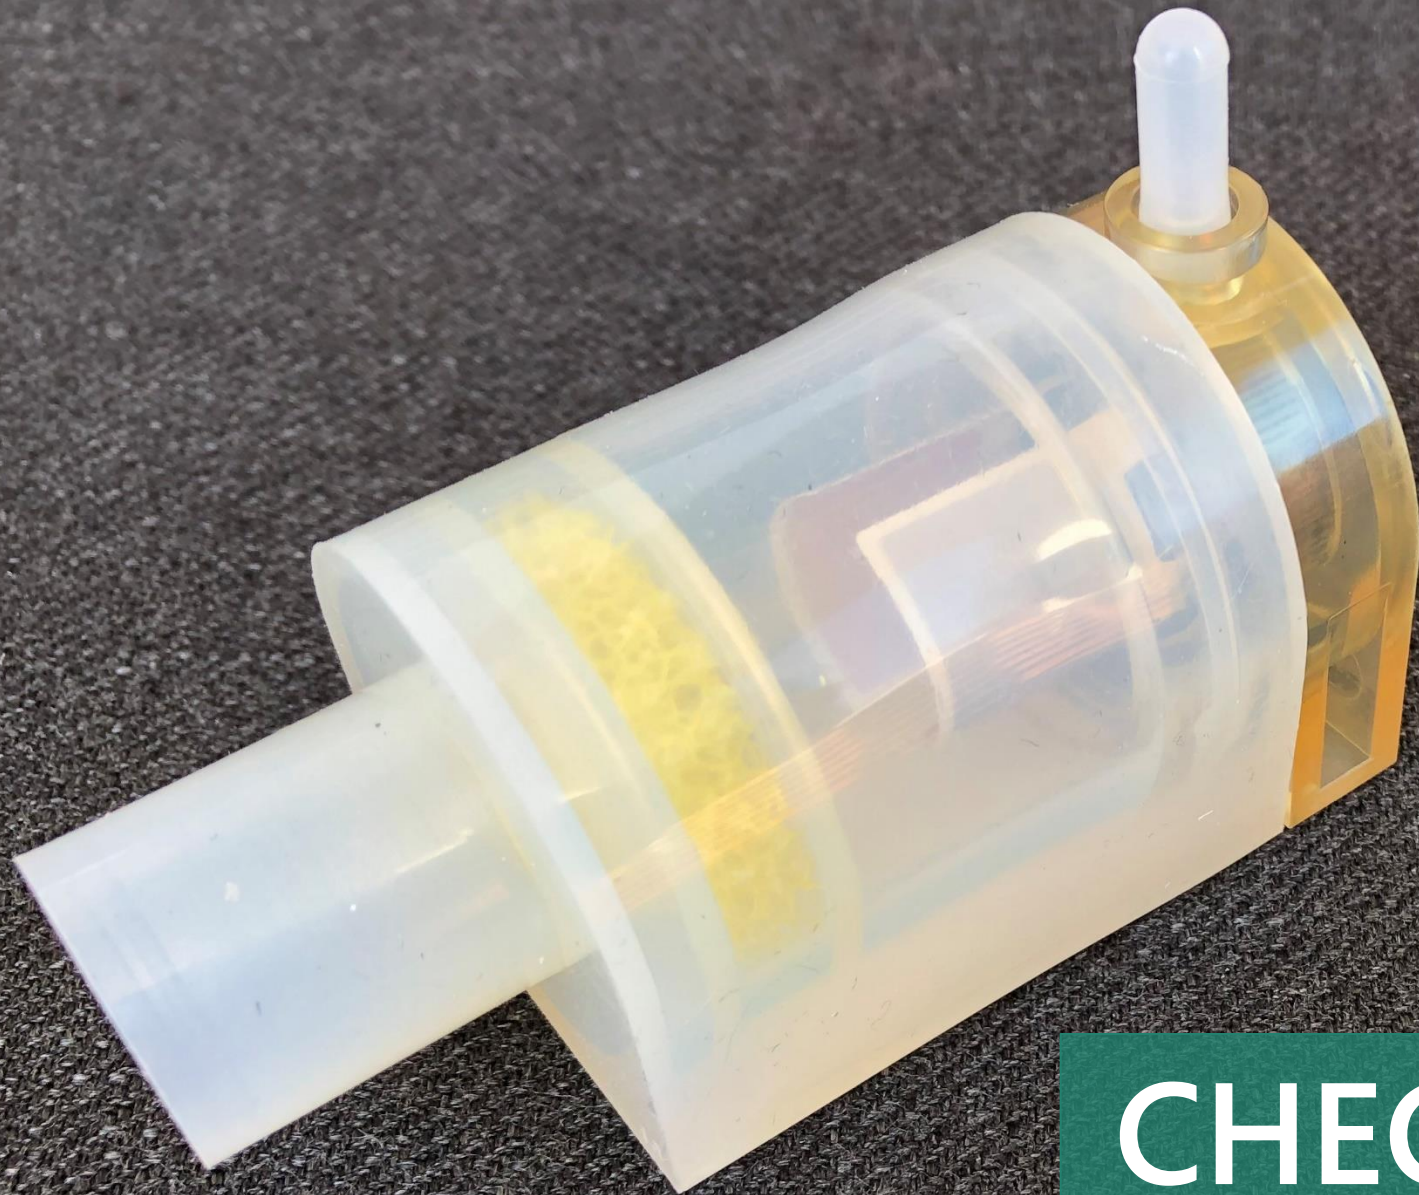
CHECK THE SENSOR

NOT CORRECT FILTER POSITION

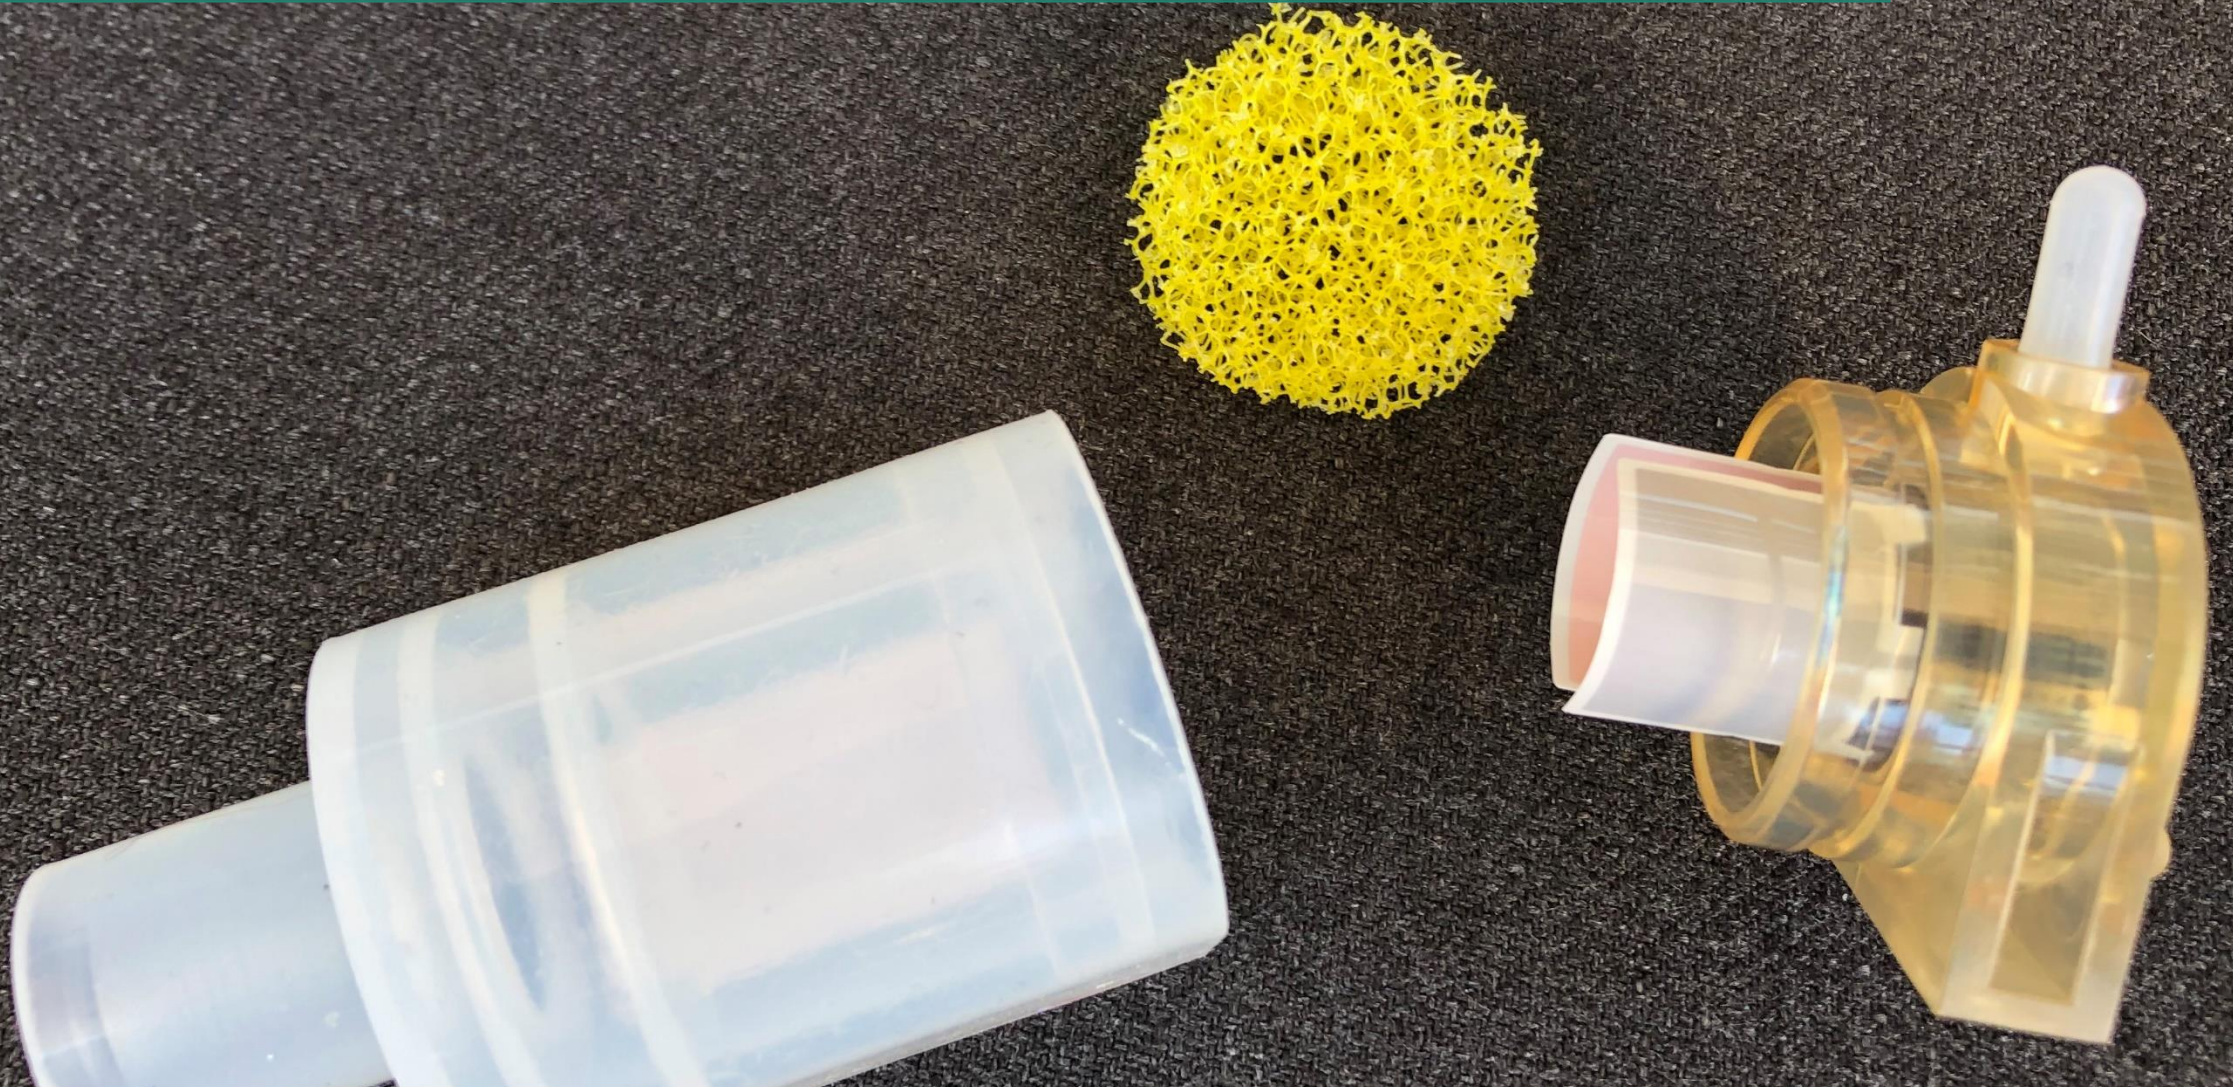
IF IT DOESN'T HELP:

– COLLECT PUMP SERIAL NO.

– REPLACE THE SENSOR

Part No. 3004113

– REPORT THE CLAIM
